TECHNICAL REPORT NO. 261

The Grand Opening of the Las Campanas Zoo

Abstract

The zoo software is installed in Las Campanas on a new computer. The instruments are cleaned, the alignment checked, and all other electronics re-calibrated.

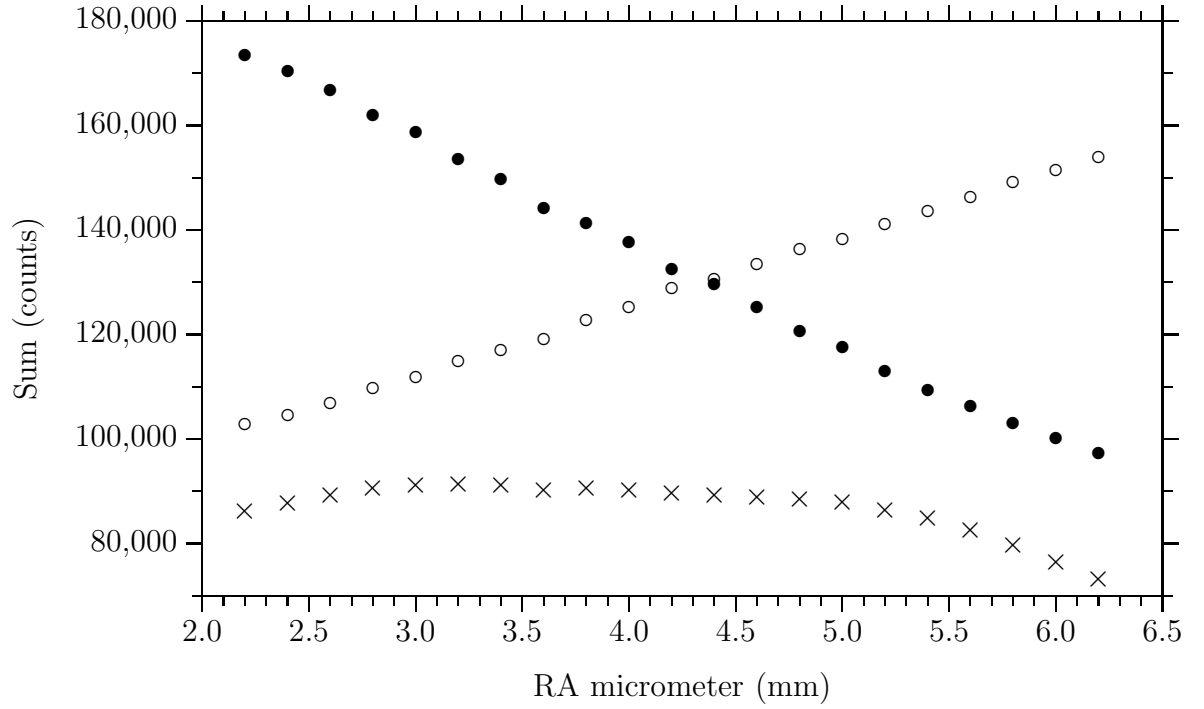
Figure 1: Hannibal sums from an right-ascension autoguider scan. The plot shows how the starboard sum (●), port sum (○), and transmitted sum (×) varied. The transmission monitor data has been multiplied by two. This scan was done with the declination micrometer set at 1.6 mm.

We performed two autoguider scans in order to check the alignment of the mount. The results of the right-ascension scan are shown in Figures 1 and 2. It looks like Hannibal is centered when the right-ascension micrometer is set to 4.3 mm while Ivan is centered at 4.5 mm. The autoguider telescope is 500 mm long, so the angular offset between the two spectrometers is:

$$\theta = \frac{0.2 \text{ mm}}{500 \text{ mm}} = 0.00040 \text{ rad} = 0^{\circ}0229 = 1'.374.$$

After that scan, we set the micrometer to 4.4 mm hoping that this would be in the middle. But it looked like this now favored Ivan, so we nudged the micrometer back to 4.3 mm. Incidentally, the micrometer was set at 4.2 mm before we began the scans.

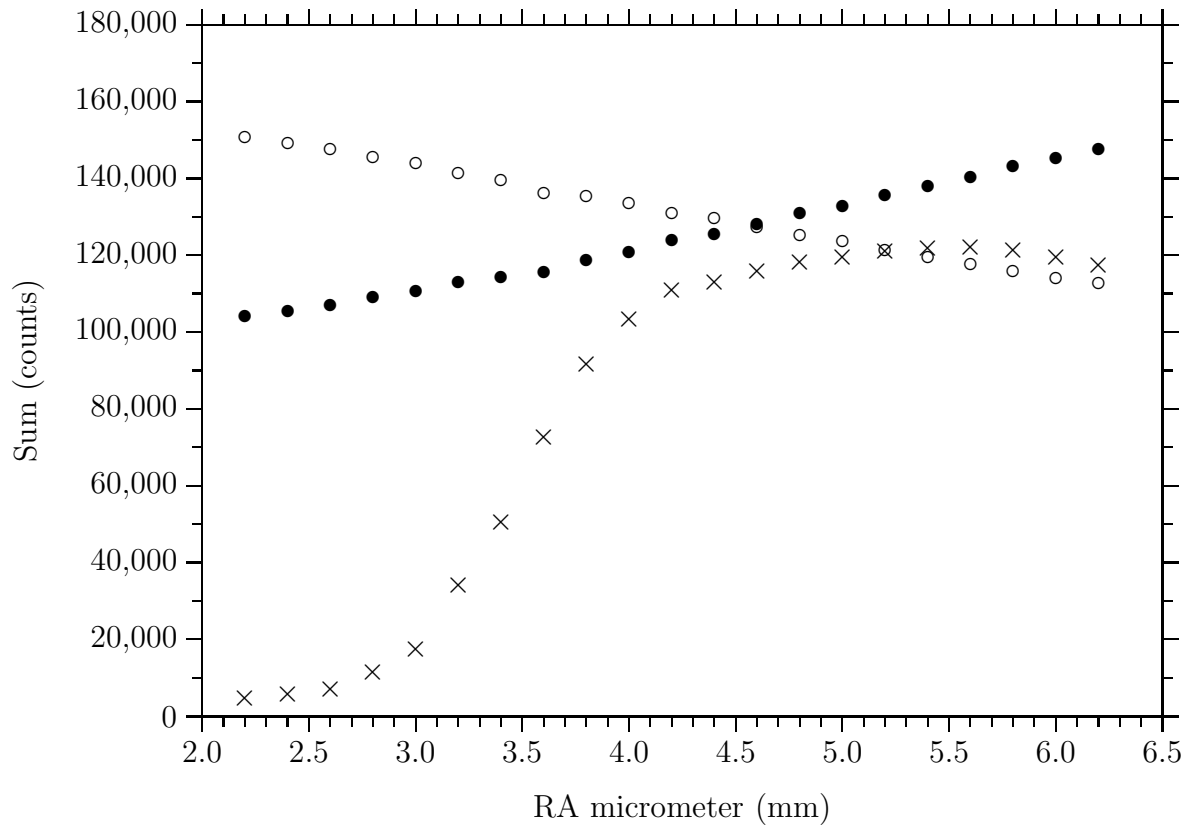
Figure 2: Ivan sums from an right-ascension autoguider scan. The plot shows how the starboard sum (●), port sum (○), and transmitted sum (×) varied. The transmission monitor data has been multiplied by ten. This scan was done with the declination micrometer set at 1.6 mm.

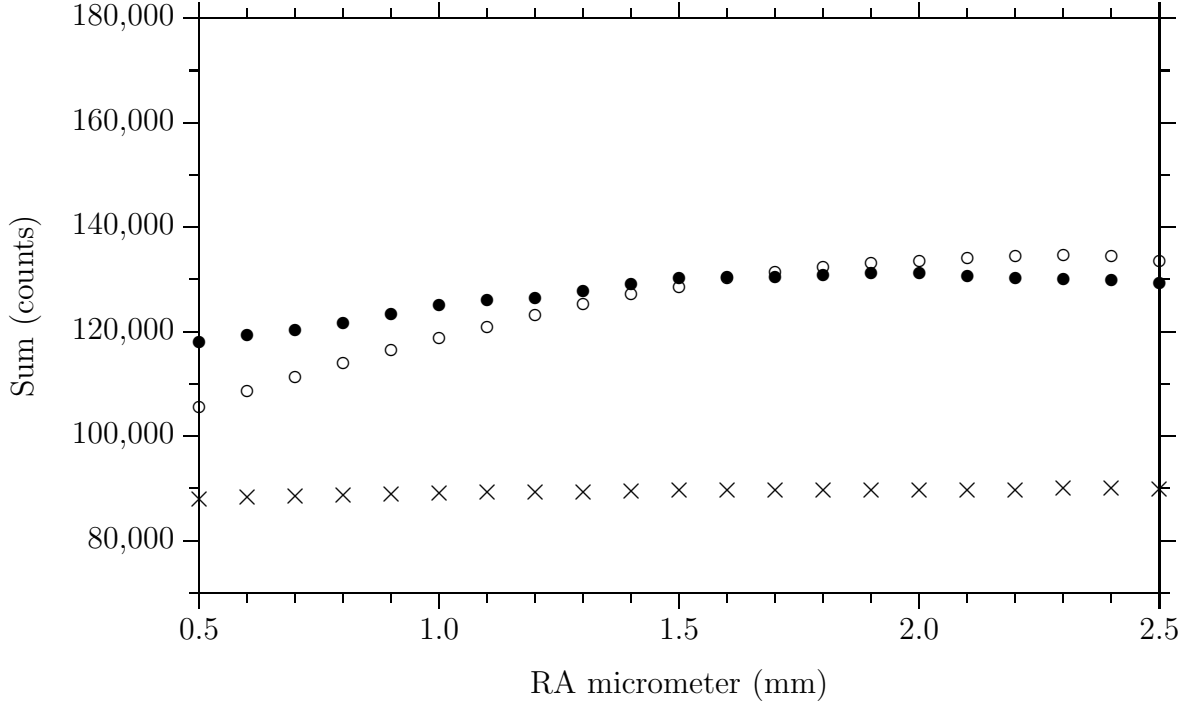
Figure 3: Hannibal sums from an declination autoguider scan. The plot shows how the starboard sum (●), port sum (○), and transmitted sum (×) varied. The transmission monitor data has been multiplied by two. This scan was done with the declination micrometer set at 4.2 mm.

The results of the declination scan are shown in Figures 3 and 4. It looks like Hannibal wants the declination micrometer set to 2.0 mm while Ivan wants 1.25 mm. We compromised and set it at 1.6 mm. Before the scan, the micrometer was set to 1.4 mm.

$$\theta = \frac{0.75 \text{ mm}}{500 \text{ mm}} = 0.00150 \text{ rad} = 0^\circ 08' 59'' = 5'16''.$$

The center box in the mount is 290 mm long. To correct this error, we would need a 0.435-mm-thick shim under the front of Ivan.

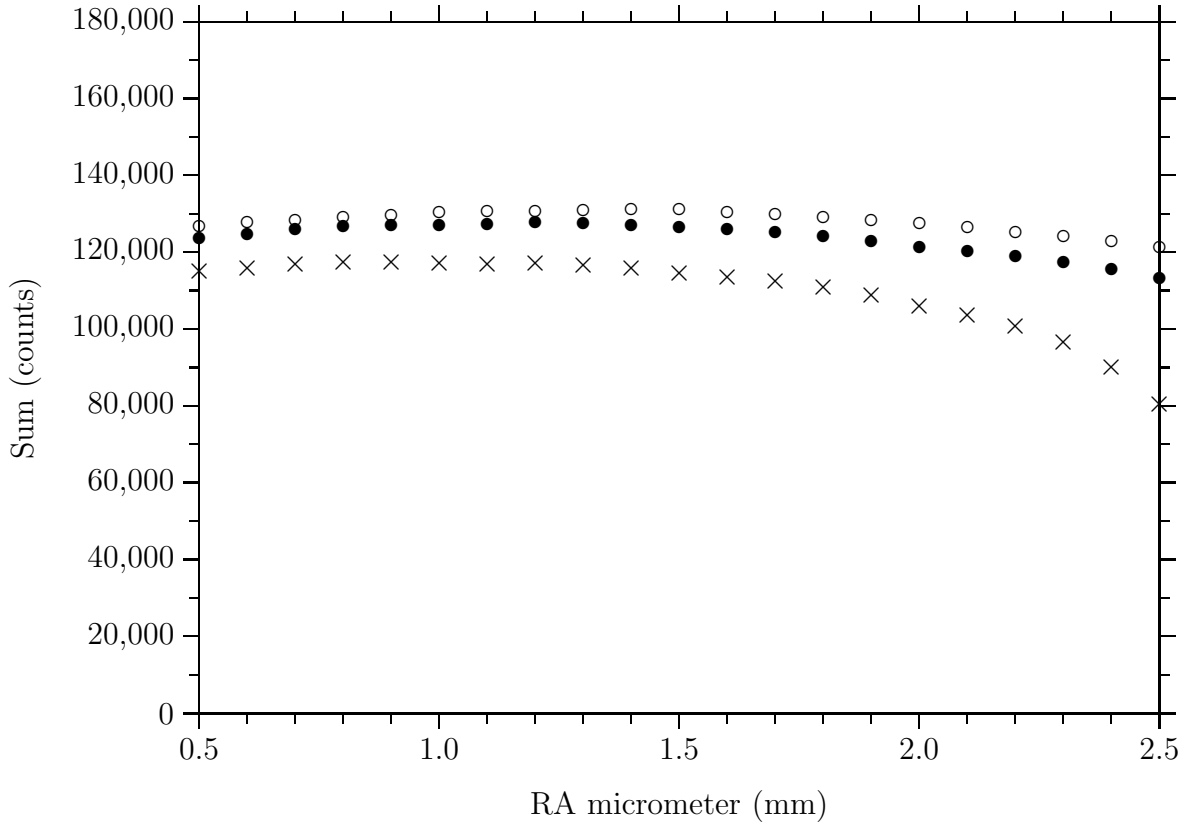
Figure 4: Ivan sums from an declination autoguider scan. The plot shows how the starboard sum (●), port sum (○), and transmitted sum (×) varied. The transmission monitor data has been multiplied by ten. This scan was done with the declination micrometer set at 4.2 mm.
